Rain infiltration mechanisms in ventilated façades: literature review, case studies, understanding common practice flaws

KEYWORDS: Ventilated façades, watertightness performance, damages, design guidelines.

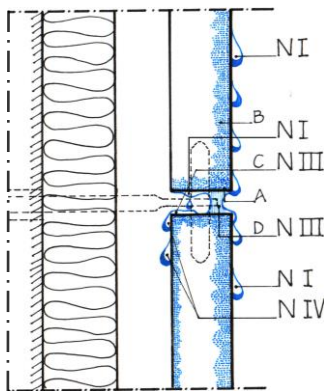
Figure 11. Vertical section (middle of the stone plaque).

Unlike vertical joints, the width and shape of horizontal joints enables the direct entry of wind-driven raindrops to level VII (see A in Fig. 11 and 13). Rainwater impinging on the stone plaques will run down on its exterior surface by gravity (level I) until it reaches the lower edge. Note that whereas the zinc is an impermeable material, the limestone is a porous material that will absorb some of the water contained in the rivulet (see B in Fig. 11). Then, water might flow sideways along the border and the lower face of the plaque by surface tension (see A in Fig. 12 and Fig. 1). When the water bubble formed is big enough to enable the superiority of gravity action over surface tension, rainwater might drip in the top face of the adjacent panel (level III), where it can remain stagnant or flow sideways or leak down the inner surface of the plaque by gravity (level IV; C in Fig. 11). The rainwater running down in level I can also bridge the gap of the horizontal joint and continue its downward flow along the adjacent plaque (level I; D in Fig. 11). If the rivulet is located near the anchorages, rainwater coming from level I and flowing sideways along the lower face of the plaque might infiltrate into the gap by capillary forces (level I; B in Fig. 12). In contrast, the water retained in level III might drip into

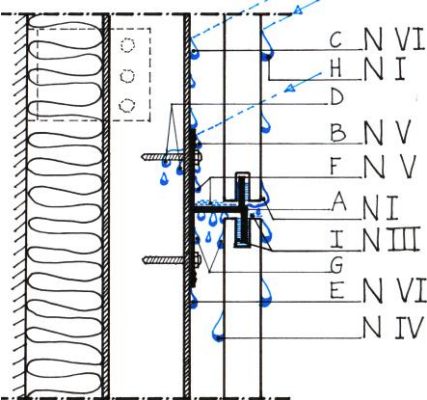
Figure 17. Vertical section.

In this case, the entry of WDR in the cavity through the horizontal joints between panels is rather unlikely since the horizontal aluminium profile blocks its pathway (see A in Fig. 17). Contrarily, the kinetic energy of wind-driven raindrops will allow water entrance through the vertical ones easily

(level II; Fig. 18). However, whether water will reach the thermal insulation layer (level VII; B in Fig. 18) or only come into contact with the horizontal profile (level V; B in Fig. 17 and A in Fig. 18) and the vertical profile (level VI; C in Fig. 17) is uncertain. The rainwater that collides with the horizontal profile (see B in Fig. 18) will run down and accumulate at the bottom part (level V; A in Fig. 18) by gravity. Albeit, if it comes into contact with the screws it might be forced through the gap to the rod of the screw and / or the backside of the vertical profile by means of wind pressure and capillary suction (see D in Fig. 17). The rainwater impinging on the exterior surface of the vertical profile (level VI; C in Fig. 17) will trickle down by gravity until it reaches the top border of the horizontal profile. Then, it can flow down through the contact interface between the profiles (level VI; E in Fig. 17) or it can be held in the horizontal profile (level V; F in Fig. 17). If the stagnant rainwater reaches the connection between two horizontal profiles by local air currents and / or wind pressure, it might leak and run down either the inner surface of the panel (level IV) or the vertical surface of the horizontal profile (level V; G in Fig. 17). Finally, the rainwater that collides with the panel (level I; H in Fig. 17) will run down by gravity until it reaches the lower border, where it might flow sideways by surface tension and drip down in level III by gravity. Note that whereas the water flowing along the lower face of the panel (level I) might infiltrate in the anchor gap by capillary suction, the water flowing in level III might drip in the gap by gravity (see I in Fig. 17). Like in the before mentioned case, the freezing of this infiltrated rainwater might cause the spalling of the panel (see Fig. 15). In addition, red and black stains over the fibre cement panels and moisture stains over the bottom border of the façade have been identified during the inspection (see Fig. 16).
