## Potential of wind barriers to assure airtightness of wood-frame low energy Constructions

Energy and Buildings 42 (2010) 2376–2385

# Potential of using wind barriers to assure airtightness of wood-frame low energy constructions

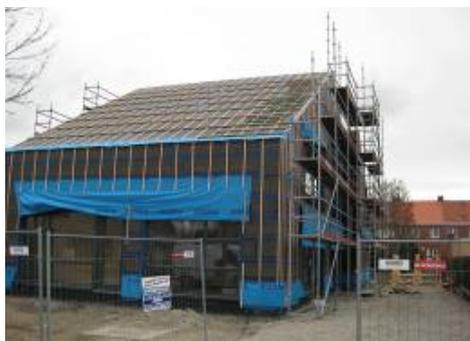
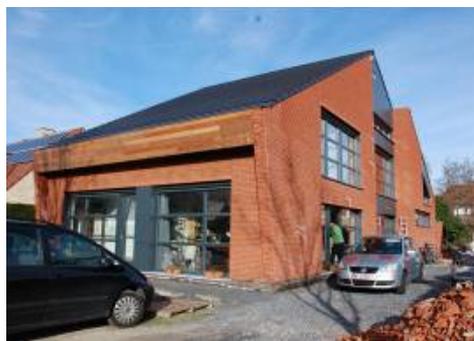
**Figure 1 (a) Wind barrier during construction stage (b) overall view of the finished house (East and South façade).**

The wind barrier consists of 18 mm thick bitumen impregnated soft fiberboards. The boards have a special watertight bitumen impregnated layer on the top face, which has a significant contribution to the airtightness of the material. Nevertheless the high air resistance, the boards have a high vapour permeability (sd-value of 0.27 m at 30% RH and 0.14 m at 80%) what makes them applicable as breather membranes on the outside of thermal insulation. The standard board has overall dimensions of 575 by 2400 mm with tongue and groove connection on all four sides [15].

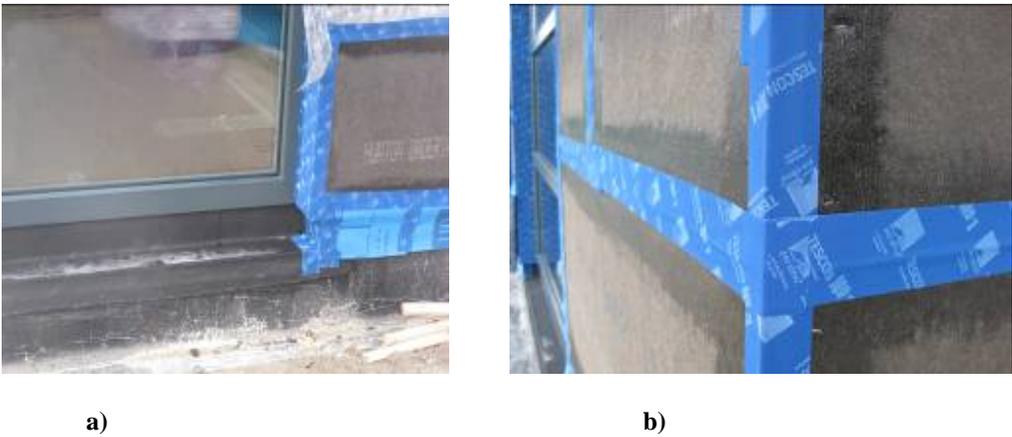
The left hand side image of Figure 2 shows how the wind barrier is sealed on the windows and on the foundation. The image on the right hand side illustrates the sealed tongue and groove joints and the connections between adjacent walls. To ensure the durability of the tape on the external fibre board, a frost-free primer is applied to the joints before being sealed.

**Figure 2 (a) Wind barrier sealed to foundation and window (b) sealed connection between adjacent walls and sealed tongue and groove joint.**

As shown in Figure 2b and 3a, the connection between the wall and the roof is of a continuous nature what makes this joint easy to seal with tape. The absence of a chimney and roof windows are other advantages of this specific case study regarding airtightness.

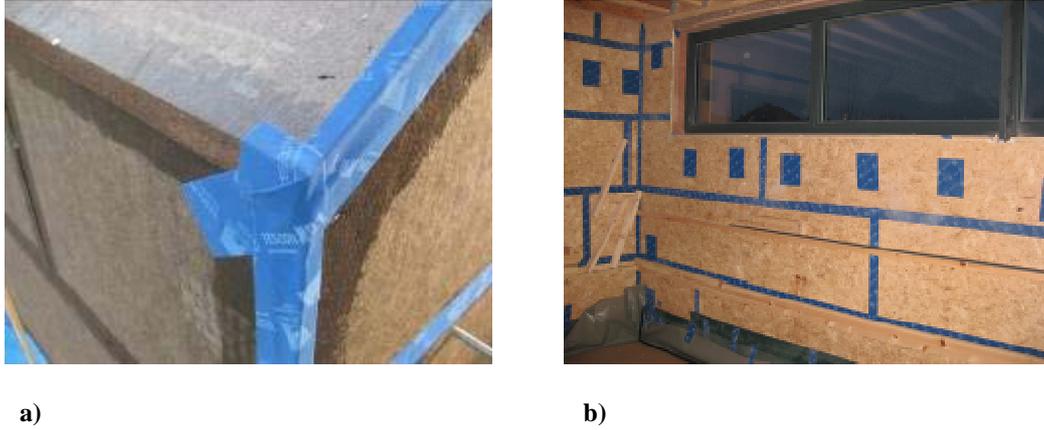
Figure 3. (a) Continuous connection between wall and roof (b) sealed tongue and groove connection between OSB and covered inflation holes

With the wind barrier totally sealed, the cellulose fibre insulation was blown in from inside through holes in the OSB. Figure 4b shows how in the last step the inflation holes and the tongue and groove connections were sealed at the inside.

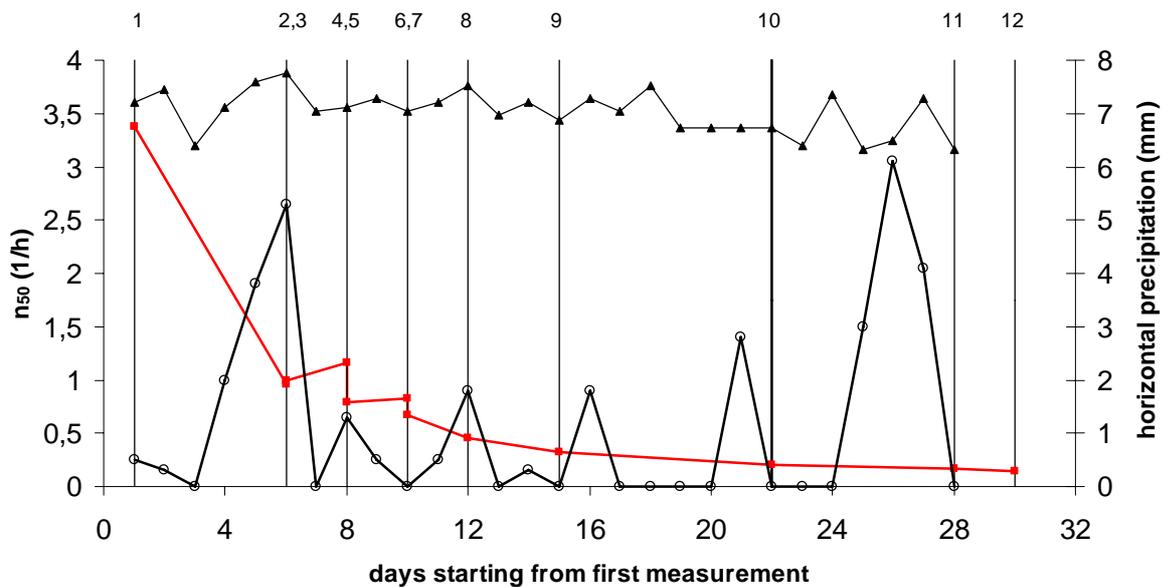
joints. To visualise this, Figure 5 plots the evolution of the airtightness against the daily horizontal precipitation (mm) and outdoor relative humidity (%). The averaged weather data were collected every 5 minutes from a ‘Davis Vantage pro 2 station’ located 3 km from the tested house.

**Figure 4 Evolution of the airtightness in the consecutive construction stages against the daily horizontal precipitation (mm) and relative humidity (%)**

Interestingly, the  $n_{50}$ -value has increased between step 3 and 4 and between step 5 and 6 (Figure 5). Furthermore, measurements 7 and 8 confirm the importance of the moisture content of the wind barrier on the airtightness. Both measurements were conducted in the same construction stage, with the weather being the only variable. Measurement 7 was performed on a sunny Friday afternoon, while measurement 8 was executed after that weekend on a rainy Monday morning. At this level of airtightness the increased moisture content of the wind barrier reduces the overall airtightness with more than 30%. To quantify the importance of the weather influences, additional air permeability tests of the wind barrier as function of the moisture content were performed in laboratory conditions. The results will be discussed in the following paragraph.

From figure 4 it is clear that the influence of the weather on the permeance of the wind barrier should be considered. To investigate the importance of the moisture content of the wind barrier, this study performed two additional laboratory test series with the small apparatus, examining the air permeability of the material and tongue and groove joints as function of the moisture content. Prior to the air permeability test, the specimens were

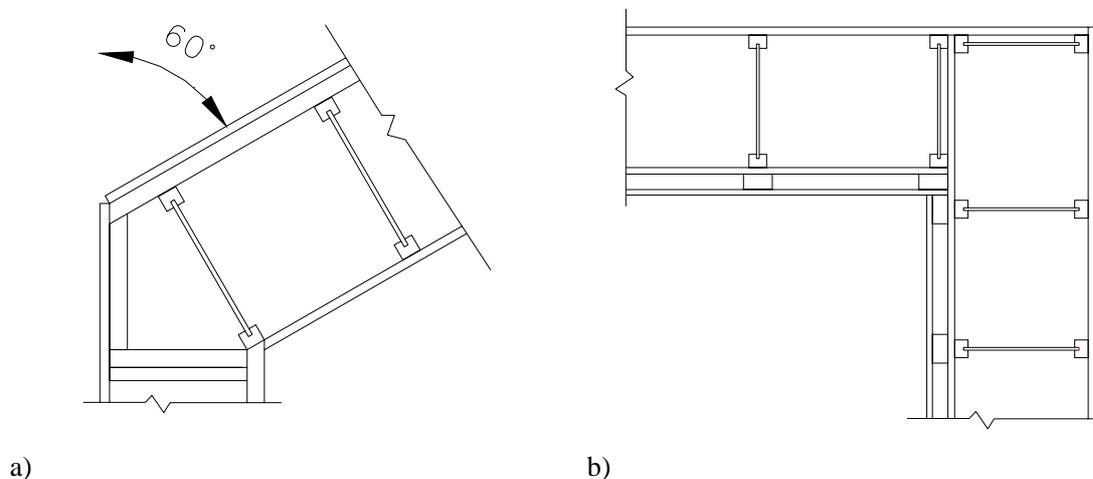
**Figure 5 (a) Wall-to-roof connection ( $30^\circ$ ) of the wind barrier in the West and East façade (21 m) (b) connections between the walls ( $90^\circ$ ).**

step 6. In step 5 already 88 m of the corner joints were sealed and in step 7 the last 11 m were taped. The joints should be differentiated between the ones describing an angle of  $30^\circ$  (21 m) and those describing an angle of  $90^\circ$  (77 m). Less air will escape through the corners of  $90^\circ$ , as these joints have more contact and are supported over the entire length by studs (Figure 5).

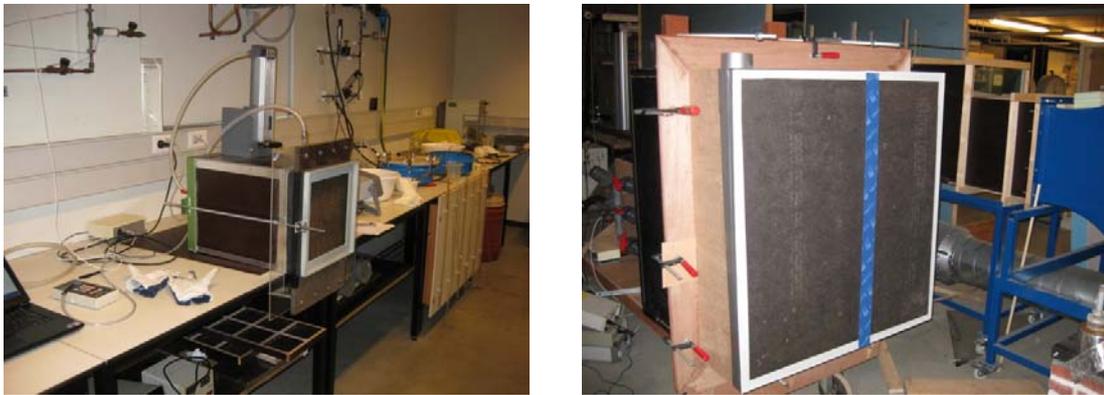
The first test setup consisted of a metal frame box open at one side to measure specimens with a size of 0,27 by 0,27 m (figure 6a). This box is used to characterise the air permeance of the materials and the typical tongue and groove connections of the board products. The second apparatus was designed for specimens of 0,85 by 0,95m and allows to mount larger specimens and 3D-construction details in a test rim on the airtight box (figure 6b). This box is used to test the corner joints between the fibreboard at an angle of 90° (as in the wall junctions) and 30° (as in the wall to roof junctions). To avoid unwanted air leakages through the perimeter joints between specimen and airtight boxes, closed cell EPDM with a thickness of 2 cm on both sides of the specimen was used to seal the specimen airtight with a metal frame against the airtight box.

**Figure 6 Laboratory test equipment to determine air permeability on material and assembly level.**

After installing the specimen on the airtight box, under-pressure was created in the box. This resulted in an air flow passing through the specimen. For a stepwise increase of the pressure difference across the specimen, the air flow rate and associated pressure difference across the specimen were measured. The data sets gained in this way are curved fitted with Eq. (1). The airflow  $g_a$  ( $\text{m}^3/\text{m}^2/\text{h}$ ) can also be written as an air permeance  $K_a$  multiplied by the pressure drop across the specimen  $\Delta P_a$ . After recombination with Eq.(1), the air permeance  $K_a$  ( $\text{m}^3/\text{m}^2/\text{h}/\text{Pa}$ ) is expressed as a function of the pressure drop across the specimen [20]:

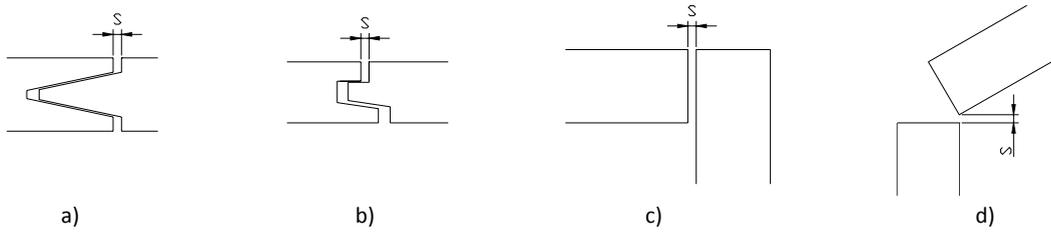
**Figure 7** Geometry of the tested joints: (a) AIF tongue and groove joint, (b) OSB tongue and groove joint, (c) AIF corner joint (90°), (d) AIF corner joint (30°)

Table 4 lists the results for the air permeability of the used fibreboards in the case study and the corresponding joints which are depicted in figure 7. In addition to the used asphalted impregnated fibreboards (AIF<sup>a</sup>), the same material was also measured (AIF<sup>b</sup>), however without a top layer. Table 4 reveals that the asphalted impregnated fibreboard becomes twenty times more permeable without top layer. Furthermore, this table shows that the asphalted impregnated fibreboard (AIF<sup>a</sup>) is five times more air permeable than the used OSB. It was also found that the air permeance of the tongue and groove connection between the plates of the AIF and the OSB are of the same order of magnitude, as long as they are perfectly installed. When the spacing between the boards increases due to bad workmanship, this influences most significantly the OSB. Furthermore, the corner joints of the wind barrier depend even more on the execution. Table 4 shows that the air permeance can vary with a factor up to 20 depending on the spacing between the boards.

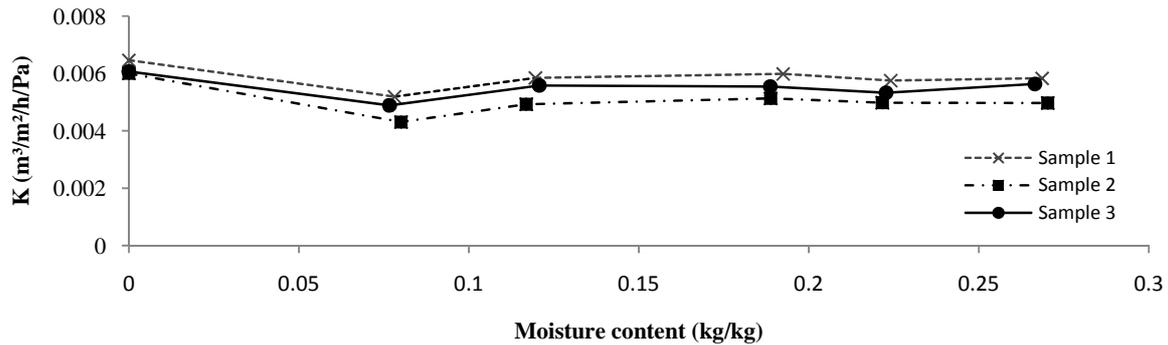
conditioned to constant moisture content: first a known water volume was applied to each specimen and secondly the specimens, wrapped in plastic foil, were stored for 4 weeks. The analysis made use of three samples of 0.35 by 0.35m for the investigation on material level. Figure 8 plots the results from these tests. This figure shows that in equilibrium conditions the air permeability of the AIF is not affected by its moisture content in this range.

**Figure 8 Wind barrier board as function of the moisture content (in equilibrium)**

When the *in situ* measurements were performed, the moisture content of the wind barrier can not be in equilibrium with the fluctuating outdoor relative humidity. During or short after a period of rain, water will be drained from the wind barrier. To simulate this effect in laboratory conditions, the specimens were sprayed on the top layer until water starts to drain. Both, immediately after this wetting process and 30 minutes later, the permeability was measured. For all three samples the permeability, straight after wetting was reduced within a range from 51-58% compared to the dry situation. However, after 30 minutes, the permeance reached again 91-96% of the level in dry conditions. From this we can conclude that permeability at material level is rather independent of moisture content. Only short after wetting the board, the influence should be considered.

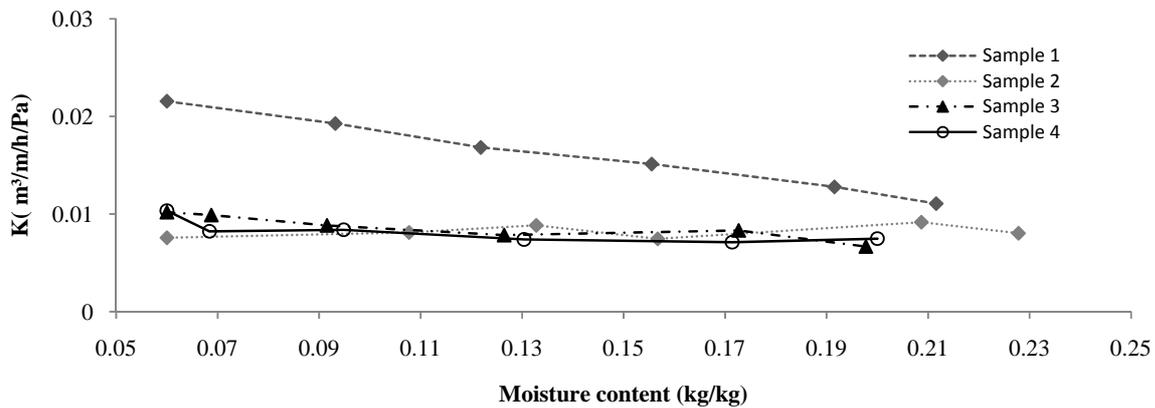
In addition also the behaviour of the tongue and groove joint was studied. Four specimens of the wind barrier with a tongue groove joint were mounted on a plastic frame. The specimens were only fixed parallel to the joints, to assure the joints' possibility to swell. Three of the joints were attached perfectly and one was fixed creating a joint of 2mm. The same wetting procedure as described above was applied to condition the specimens. Figure 9 depicts the results from the tests with the moisture content in equilibrium. It appears that only the joint of 2 mm was significantly influenced by the moisture content of the boards.

In a second step, the specimens were sprayed with water and measured. This showed that the permeability of the joints was affected with less than 5%, both immediately after and 30 minutes after the specimens were sprayed. Hence, we conclude that the air permeance of the joints is only significantly affected by its moisture content, if the joints do not perfectly fit due to bad workmanship.

Figure 9 Tongue and groove joints through the wind barrier as function of the moisture content (in equilibrium)
