Proceeding

Non-Destructive Testing of Composites by Ultrasound, Local Defect Resonance and Thermography †

† Presented at 18th International Conference on Experimental Mechanics, Brussels, Belgium, July 1-5 2018.

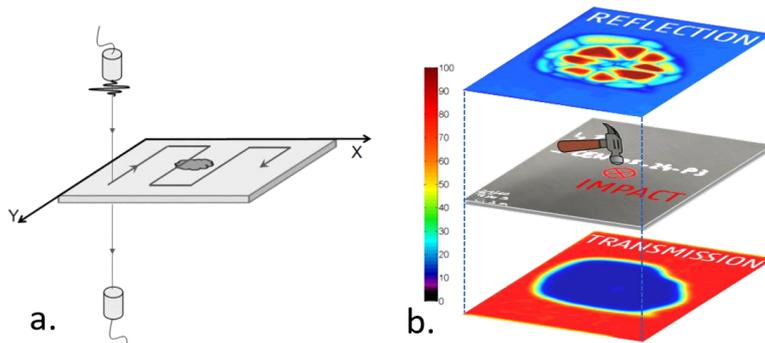
Figure 1: (a) Principle of C-scan and (b) ultrasonic C-scan in reflection (top) and transmission (bottom) for an impacted $[45/0/-45/90]_{3s}$ CFRP (middle) with impact energy 18.5 J. The color scale indicates the amplitude level.

The ultrasonic C-scan is perhaps the most widespread NDT technique [2]. In this technique, the surface of an immersed sample is scanned (see Figure 1), and a projection of the reflected and/or transmitted ultrasound is analyzed. Hence, it is a volumetric inspection method. The transmission C-scan leads to an integrated view of the damage zone, while the reflection C-scan provides details on the depth distribution of the damage zone (see Figure 1b). Typical frequencies are in the low MHz range (1-10 MHz) for composite materials. Lowering the frequency leads to poor spatial resolution as depth profiling is directly related to the ultrasonic wavelength. Increasing the frequency leads to excessive attenuation of the ultrasonic signal in composite materials due to high damping properties of the polymer matrix and scattering at fiber bundles and porosities.

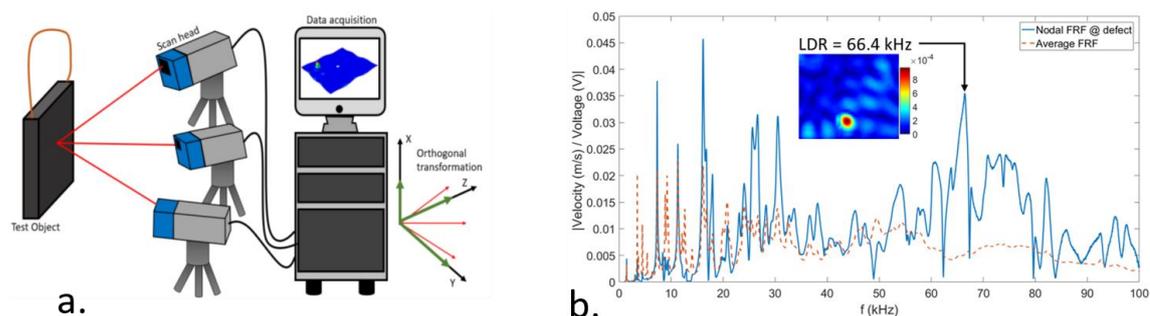
Figure 2: (a) Principle of 3D scanning laser Doppler vibrometry and (b) FRF of a [45/0/-45/90]_{3S} CFRP sample with a flat bottom hole (diameter of 10 mm).

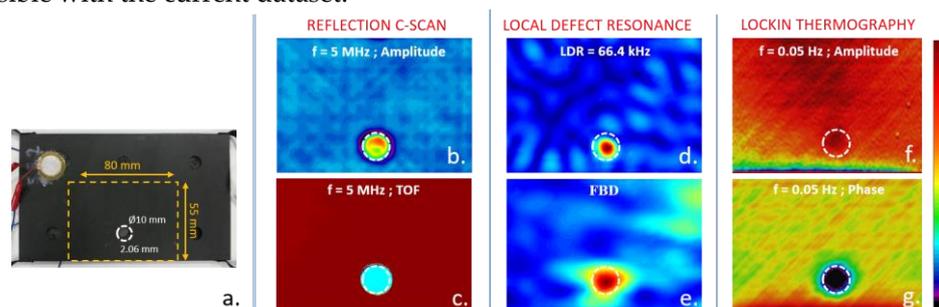
Figure 3: Results for CFRP_{FBH} : (a) photograph of inspected area. Ultrasonic C-scan at 5 MHz: (b) reflected amplitude and (c) TOF. Vibrational testing: (d) LDR at 66.4 kHz and (e) frequency band data FBD over 50-100 kHz. Lock-in thermography at 0.05 Hz: (f) amplitude and (g) phase image.

The inspection results for the CFRP_{FBH} sample are shown in Figure 3. The different inspections have been performed from the blind side of the FBH.

The ultrasonic C-scan in reflection (see Figure 3b-c) gives good estimation of the defect's lateral characteristics. Additional analysis of the TOF signal gives a depth estimation of 1.95 mm (versus 2.06 mm measured).

The results for the LDR are shown in Figure 3d-e. The LDR frequency was determined at 64.4 kHz, and the defect shape is easily recognizable (see Figure 3d) but is underestimated. This could have been expected as the defect can be perceived as a clamped sub-component. Hence, the outer part of the defect has reduced vibrational mobility compared to the inner part of the defect. The depth of the defect can be estimated on the basis of a simplified analytical solution [6], but only on the condition that defect geometry, defect size and material parameters (density, anisotropic stiffness tensor) are known a priori. Unfortunately such a priori information is often unknown, even for this model sample. The frequency band data FBD over 50-100 kHz is shown in Figure 3e and also clearly reveals the location of defect (without the need to search for a LDR characteristic in the FRF data).

The lock-in thermography result in reflection is shown in Figure 3d. Four sinusoidal cycles with frequency of 0.05 Hz have been employed. The frequency of 0.05 Hz was proven to be the most sensitive for the particular depth of the FBH. The amplitude image give little to no quantitative information (at least without further post-processing). While the phase image succeeds in providing an image from which lateral defect parameters can be extracted. Extraction of the defect depth is not possible with the current dataset.

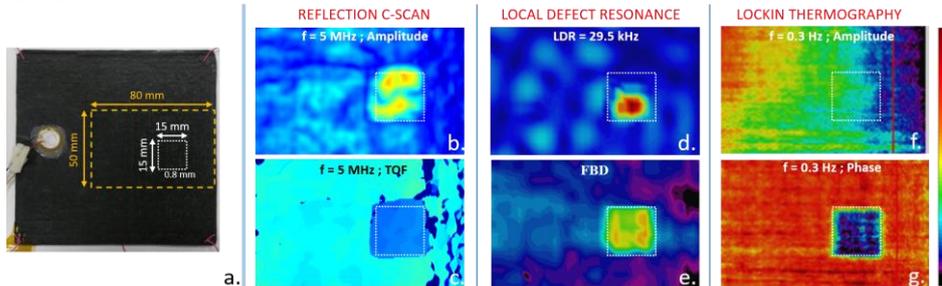
Figure 4: Results for CFRP_{INSERT}: (a) photograph of inspected area. Ultrasonic C-scan at 5 MHz: (b) reflected amplitude and (c) TOF. Vibrational testing: (d) LDR at 29.5 kHz and (e) frequency band data FBD over 5–100 kHz. Lock-in thermography at 0.3 Hz: (f) amplitude and (g) phase image.

Figure 4 presents the NDT results for the CFRP_{INSERT} sample. For this case, the three NDT techniques provide indicative results on the lateral defect parameters.

The ultrasonic C-scan nicely indicates the lateral dimensions of the defect. Though, the TOF image is of poor quality and makes it difficult to estimate the depth of the defect. This is due to the small ratio of defect-depth-to-wavelength, which makes accurate extraction of TOF troublesome, as well as to the significantly lower quality of the CFRP_{FBH} sample (when compared to the other CFRP samples). Hence, the ultrasonic signal did not show good reflection on the ETFE insert, and was therefore difficult to capture in a steady and uniform way.

For the LDR at frequency of 29.5 kHz, we got a significant underestimation of lateral defect size (see Figure 4d). On the other hand, it is interesting to note that the frequency band data FBD over 5–100 kHz (Figure 4e) gives a good estimation of actual lateral defect size, without the need to search for LDR phenomena in the average or nodal FRF data.

The IRT results have been obtained at a lock-in frequency of 0.3 Hz as this provided best results for an inspection depth of 0.8 mm. It is clear that a good contrast is obtained for the phase image, giving a good estimation of lateral defect size.

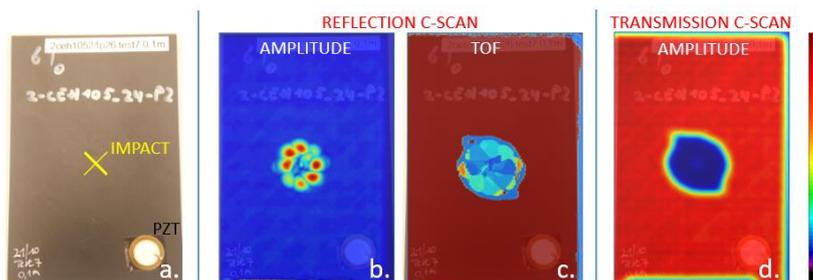
Figure 5: (a) photograph of CFRP_{BVID}, (b) amplitude reflection C-scan, (c) TOF reflection C-scan and (d) amplitude transmission C-scan.

The damage type for the CFRP_{BVID} sample (see Figure 5a) is far more complex compared to the previous two cases, and should be conceived as a combination of different defects (e.g. delamination, cracks ...) distributed through depth.

This is nicely indicated by the ultrasonic C-scan in reflection (see Figure 5 b–c). The amplitude recording indicates multiple defects at the impact location, while the TOF indicates that these defects are distributed through thickness (blue = shallow defect, red = deep defect). Analysis of the damage zone indicates that the impactor has induced a delamination cone through thickness, which extends like a double helix through the sample (and thus clearly relates to the quasi-isotropic lay-up of the [45/0/-45/90]_{3s} CFRP). Note that the upper delaminations have a shadowing effect on the lower delaminations. In reality, the deeper delaminations also extend until the impact location. The C-scan in transmission (Figure 5d) provides an integrated view of the delamination cone. Although the impact energy was only 6.3 J, the C-scan results indicate that considerable damage was induced in the CFRP laminate.

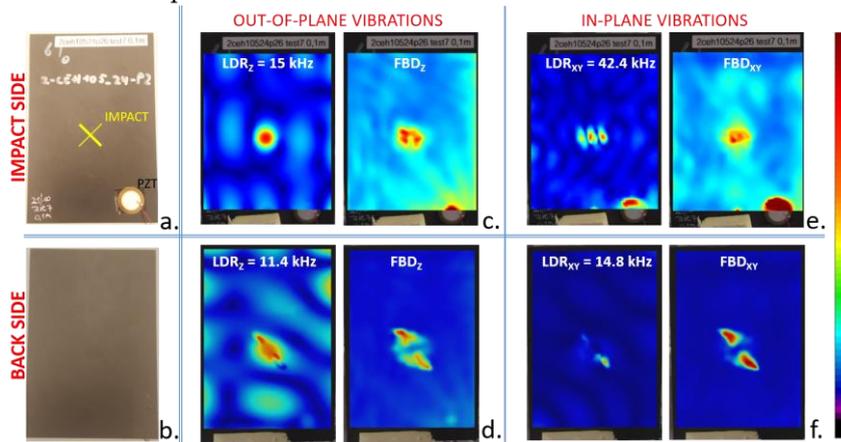
Figure 6: Results of impact side (top row) and backside (bottom row) of $CFRP_{BVID}$: (a-b) photograph of sample, (c-d) out-of-plane LDR_z and frequency band data FBD_z over 2-100 kHz and (e-f) in-plane LDR_{xy} and frequency band data FBD_{xy} over 2-100 kHz.

The LDR response for the CFRP_{BVID} sample is displayed in Figure 6. In this case, it is difficult to identify 1 single LDR frequency, exactly because of the complexity of the damage zone. The fact that LDR is not a volumetric inspection method combined with the complex 3D damage zone (see Figure 5b–c) is not favourable for clear interpretation. Therefore, the CFRP_{BVID} has been scanned at both the impact side and the backside, see Figure 6 (top row) and Figure 6 (bottom row) respectively. Additionally, the vibrational analysis was further extended towards in-plane LDR phenomena in order to get further insight on the structure of the complex 3D damage zone [14]. For clarity, the

classical out-of-plane LDR is indicated by LDR_z , while in-plane LDR is indicated by LDR_{xy} . By careful manual peak-picking, LDR_z and LDR_{xy} modes have been identified. The results indicate that the extension towards in-plane vibrational characteristics give access to other defect parameters. As there are many higher-order LDR_z and LDR_{xy} modes identified in the considered bandwidth, we opted to only show the fundamental LDR's together with a representation of the out-of-plane frequency band data FBD_z and in-plane frequency band data FBD_{xy} over the total frequency band of 2-100 kHz. The increased surface velocities of the many high order LDRs in the total frequency band should be hinted in the FBD_z and FBD_{xy} , and thus should give a representation of zones with reduced stiffness (i.e. damaged zones). The results are displayed in Figure 6c-f, and qualitatively match the ultrasonic C-scans (see Figure 5). It is clear that this set of results provides useful information, but it is equally clear that further research is needed in order to interpret these results, and eventually to link them to quantitative defect parameters.

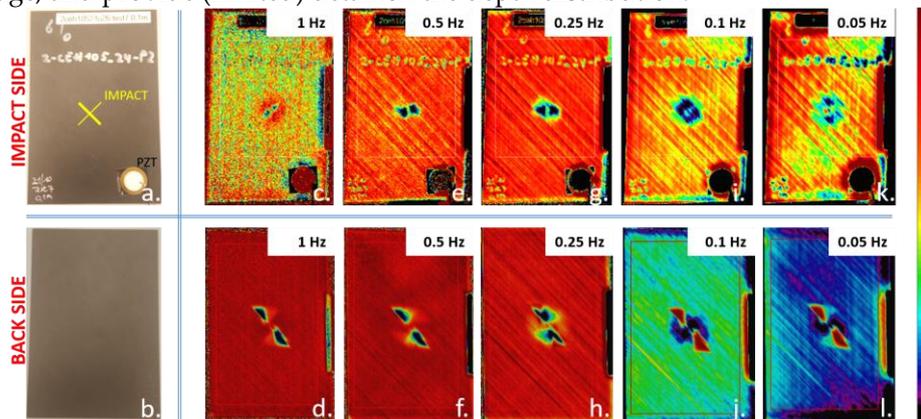
Figure 7: IRT in reflection of impact side (top row) and backside (bottom row) of $CFRP_{BVID}$: (a-b) photograph; phase images at (c-d) 1 Hz, (e-f) 0.5 Hz, (g-h) 0.25 Hz, (i-j) 0.1 Hz and (k-l) 0.05 Hz.

Finally, the lock-in thermography has been applied on the $CFRP_{BVID}$ sample. Considering that the delamination cone is distributed through thickness, various lock-in frequencies have been selected. As the $CFRP_{BVID}$ sample has a high thickness, one should select very low frequency to probe the complete sample in reflection mode (under the assumption that the SNR is still sufficient). Such low frequencies would result in unacceptable heating ($T > 100^\circ C$) of the front surface, and subsequent degradation of the thermoset matrix in the $CFRP_{BVID}$. Instead, it was opted to perform IRT in reflection from both the impact side and the backside of the $CFRP_{BVID}$ sample. The IRT results are displayed in Figure 7, and cover the frequencies 1 Hz, 0.5 Hz, 0.25 Hz, 0.1 Hz and 0.05 Hz. The difference between inspection from impact side and backside is clear. The results globally indicate the extent of the damage, and provide (limited) detail on the depth distribution.
